Project: Oak Ridge Residence

Project #: WL-2026-0847

Date of loss: July 12, 2026

Claim #: CLM-2026-0847

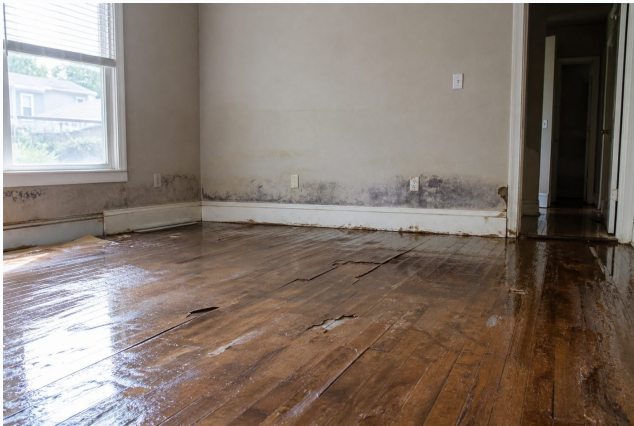
#### Photo 1

Category 2 water — baseboards swollen; flooring cupped at south wall.

Living Room — wet flooring and baseboard damage

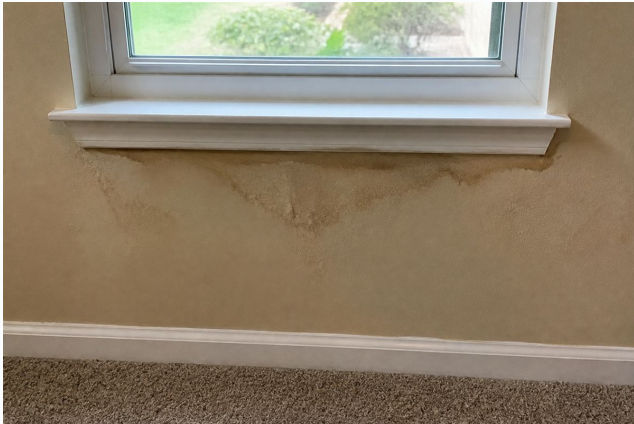
#### Photo 2

North window wall — moisture staining on drywall below sill.

Living Room — window wall moisture stain

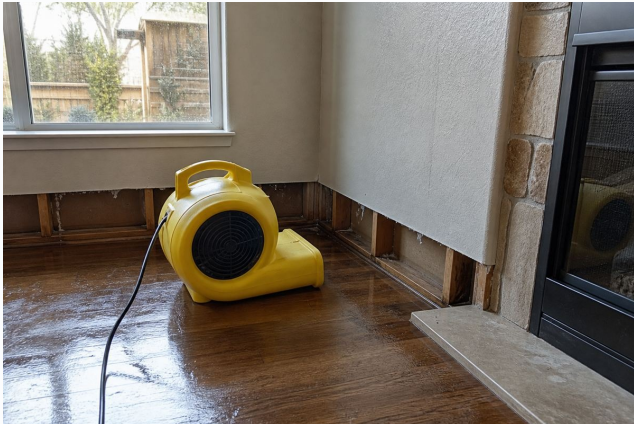
### Photo 3

Air mover placed at SE corner — directed at wet wall cavity.

Living Room — drying equipment placement

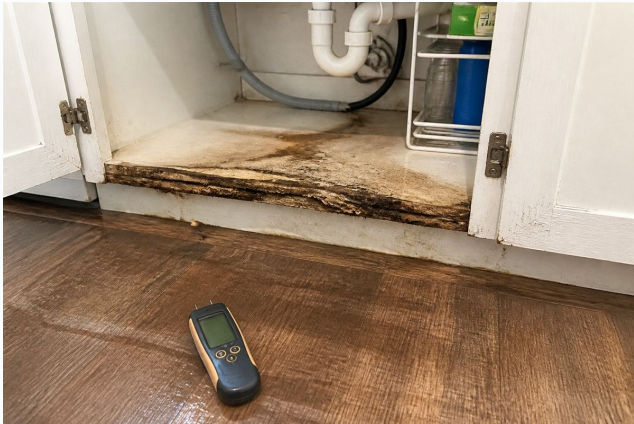
#### Photo 4

Kitchen — cabinet toe-kicks wet; meter reading elevated at sink base.

Kitchen — wet cabinets and sink base

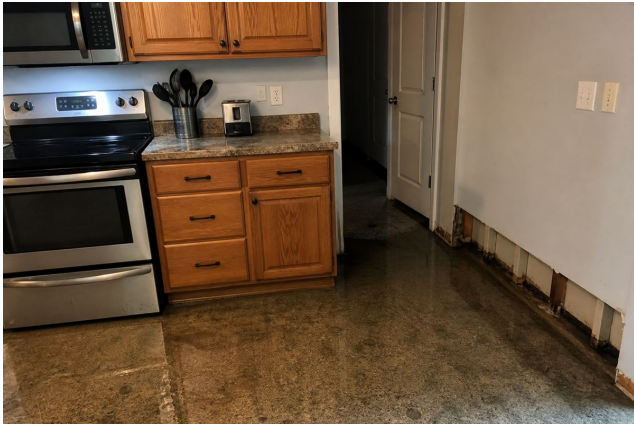
### Photo 5

Cooktop wall — no fire damage; water migrated from hall.

Kitchen — cook area after water migration

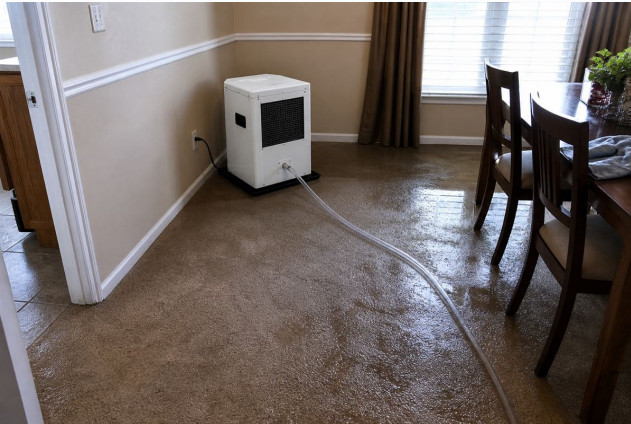
### Photo 6

Dining — carpet pad saturated; dehumidifier staged in corner.

Dining — saturated flooring and dehu placement

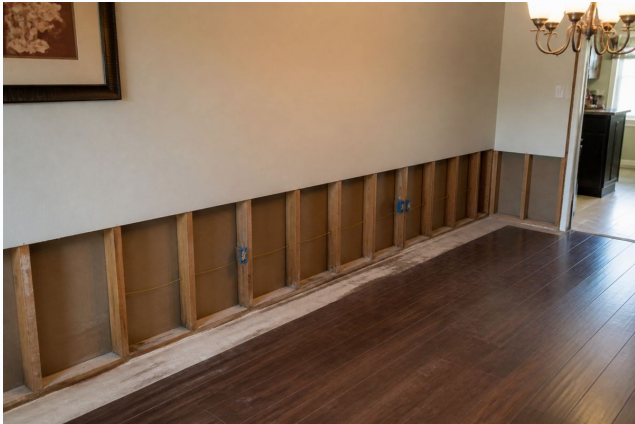
#### Photo 7

East wall — drywall removed to 2 ft; cavity drying in progress.

Dining — demo cut and cavity drying

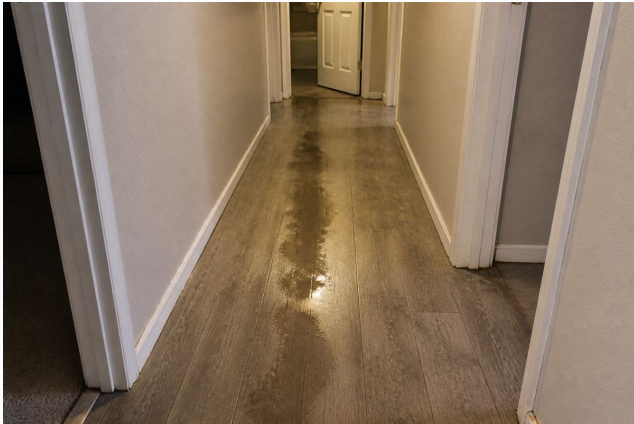
### Photo 8

Hall west — source path from living; moisture map updated.

Hall — west corridor moisture path

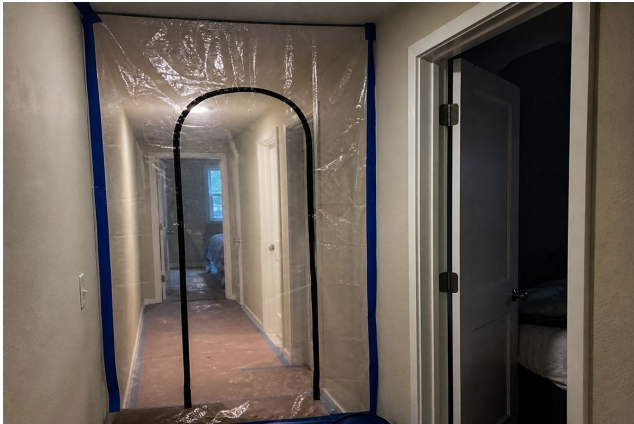
### Photo 9

Hall east — containment zipper toward bedrooms.

Hall — east corridor containment

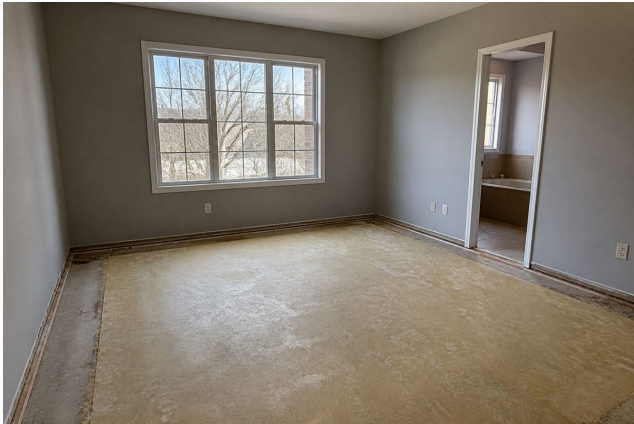
#### Photo 10

Primary bedroom — contents packed out; flooring removed at perimeter.

Bedroom 1 — pack-out and perimeter demo

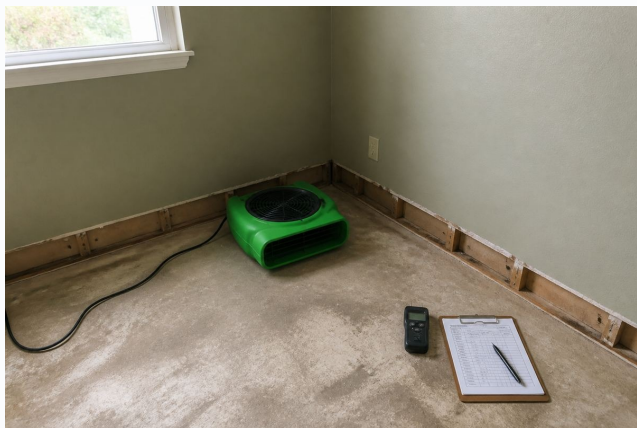
#### Photo 11

Northeast corner — air mover on wet wall; daily readings logged.

Bedroom 1 — equipment and moisture readings

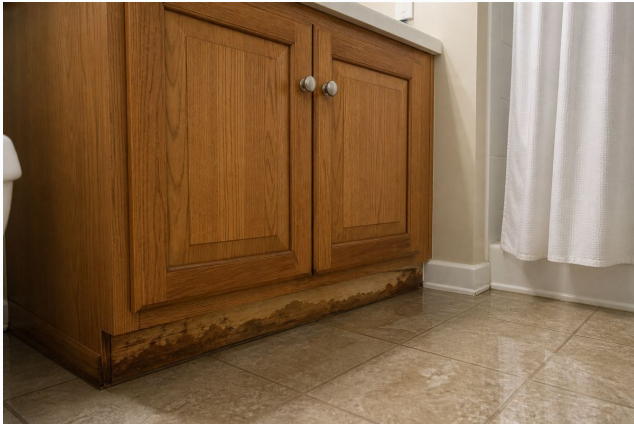
**Photo 12**

Bath — vanity kick plate wet; possible secondary source checked.

Bath — vanity and wet kick plate

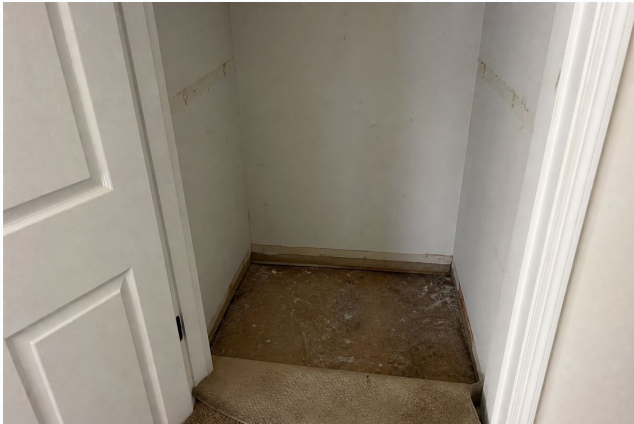
**Photo 13**

Closet — contents removed; base plate moisture confirmed.

Closet — cleared for drying access

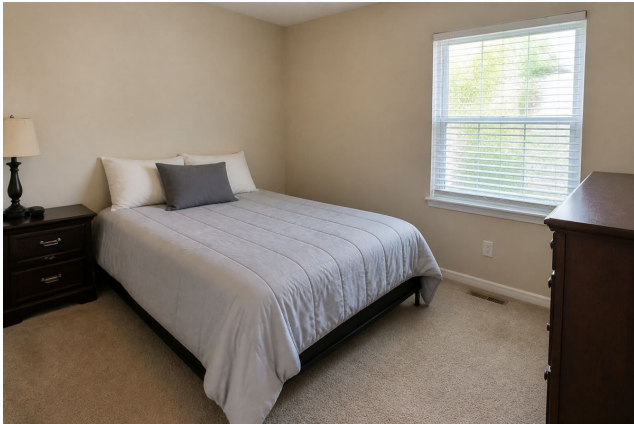
**Photo 14**

Secondary bedroom — unaffected finishes; control readings taken.

Bedroom 2 — control area / unaffected finishes

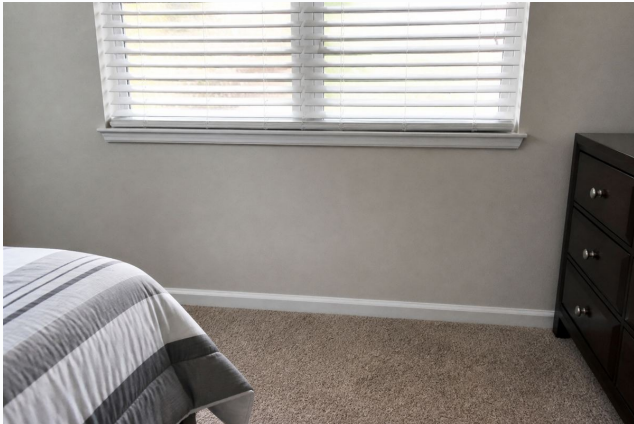
#### Photo 15

East window — no intrusion; used as dry baseline photo.

Bedroom 2 — dry baseline at window wall
